**AGEC COOLE WIND FARM CABLE  
ROUTE PRIORITY AREA SURVEY**

## **COOLE WIND FARM CABLE ROUTE PRIORITY AREA SURVEY**

**McCarthy Keville O'Sullivan Ltd**

**April 2017**

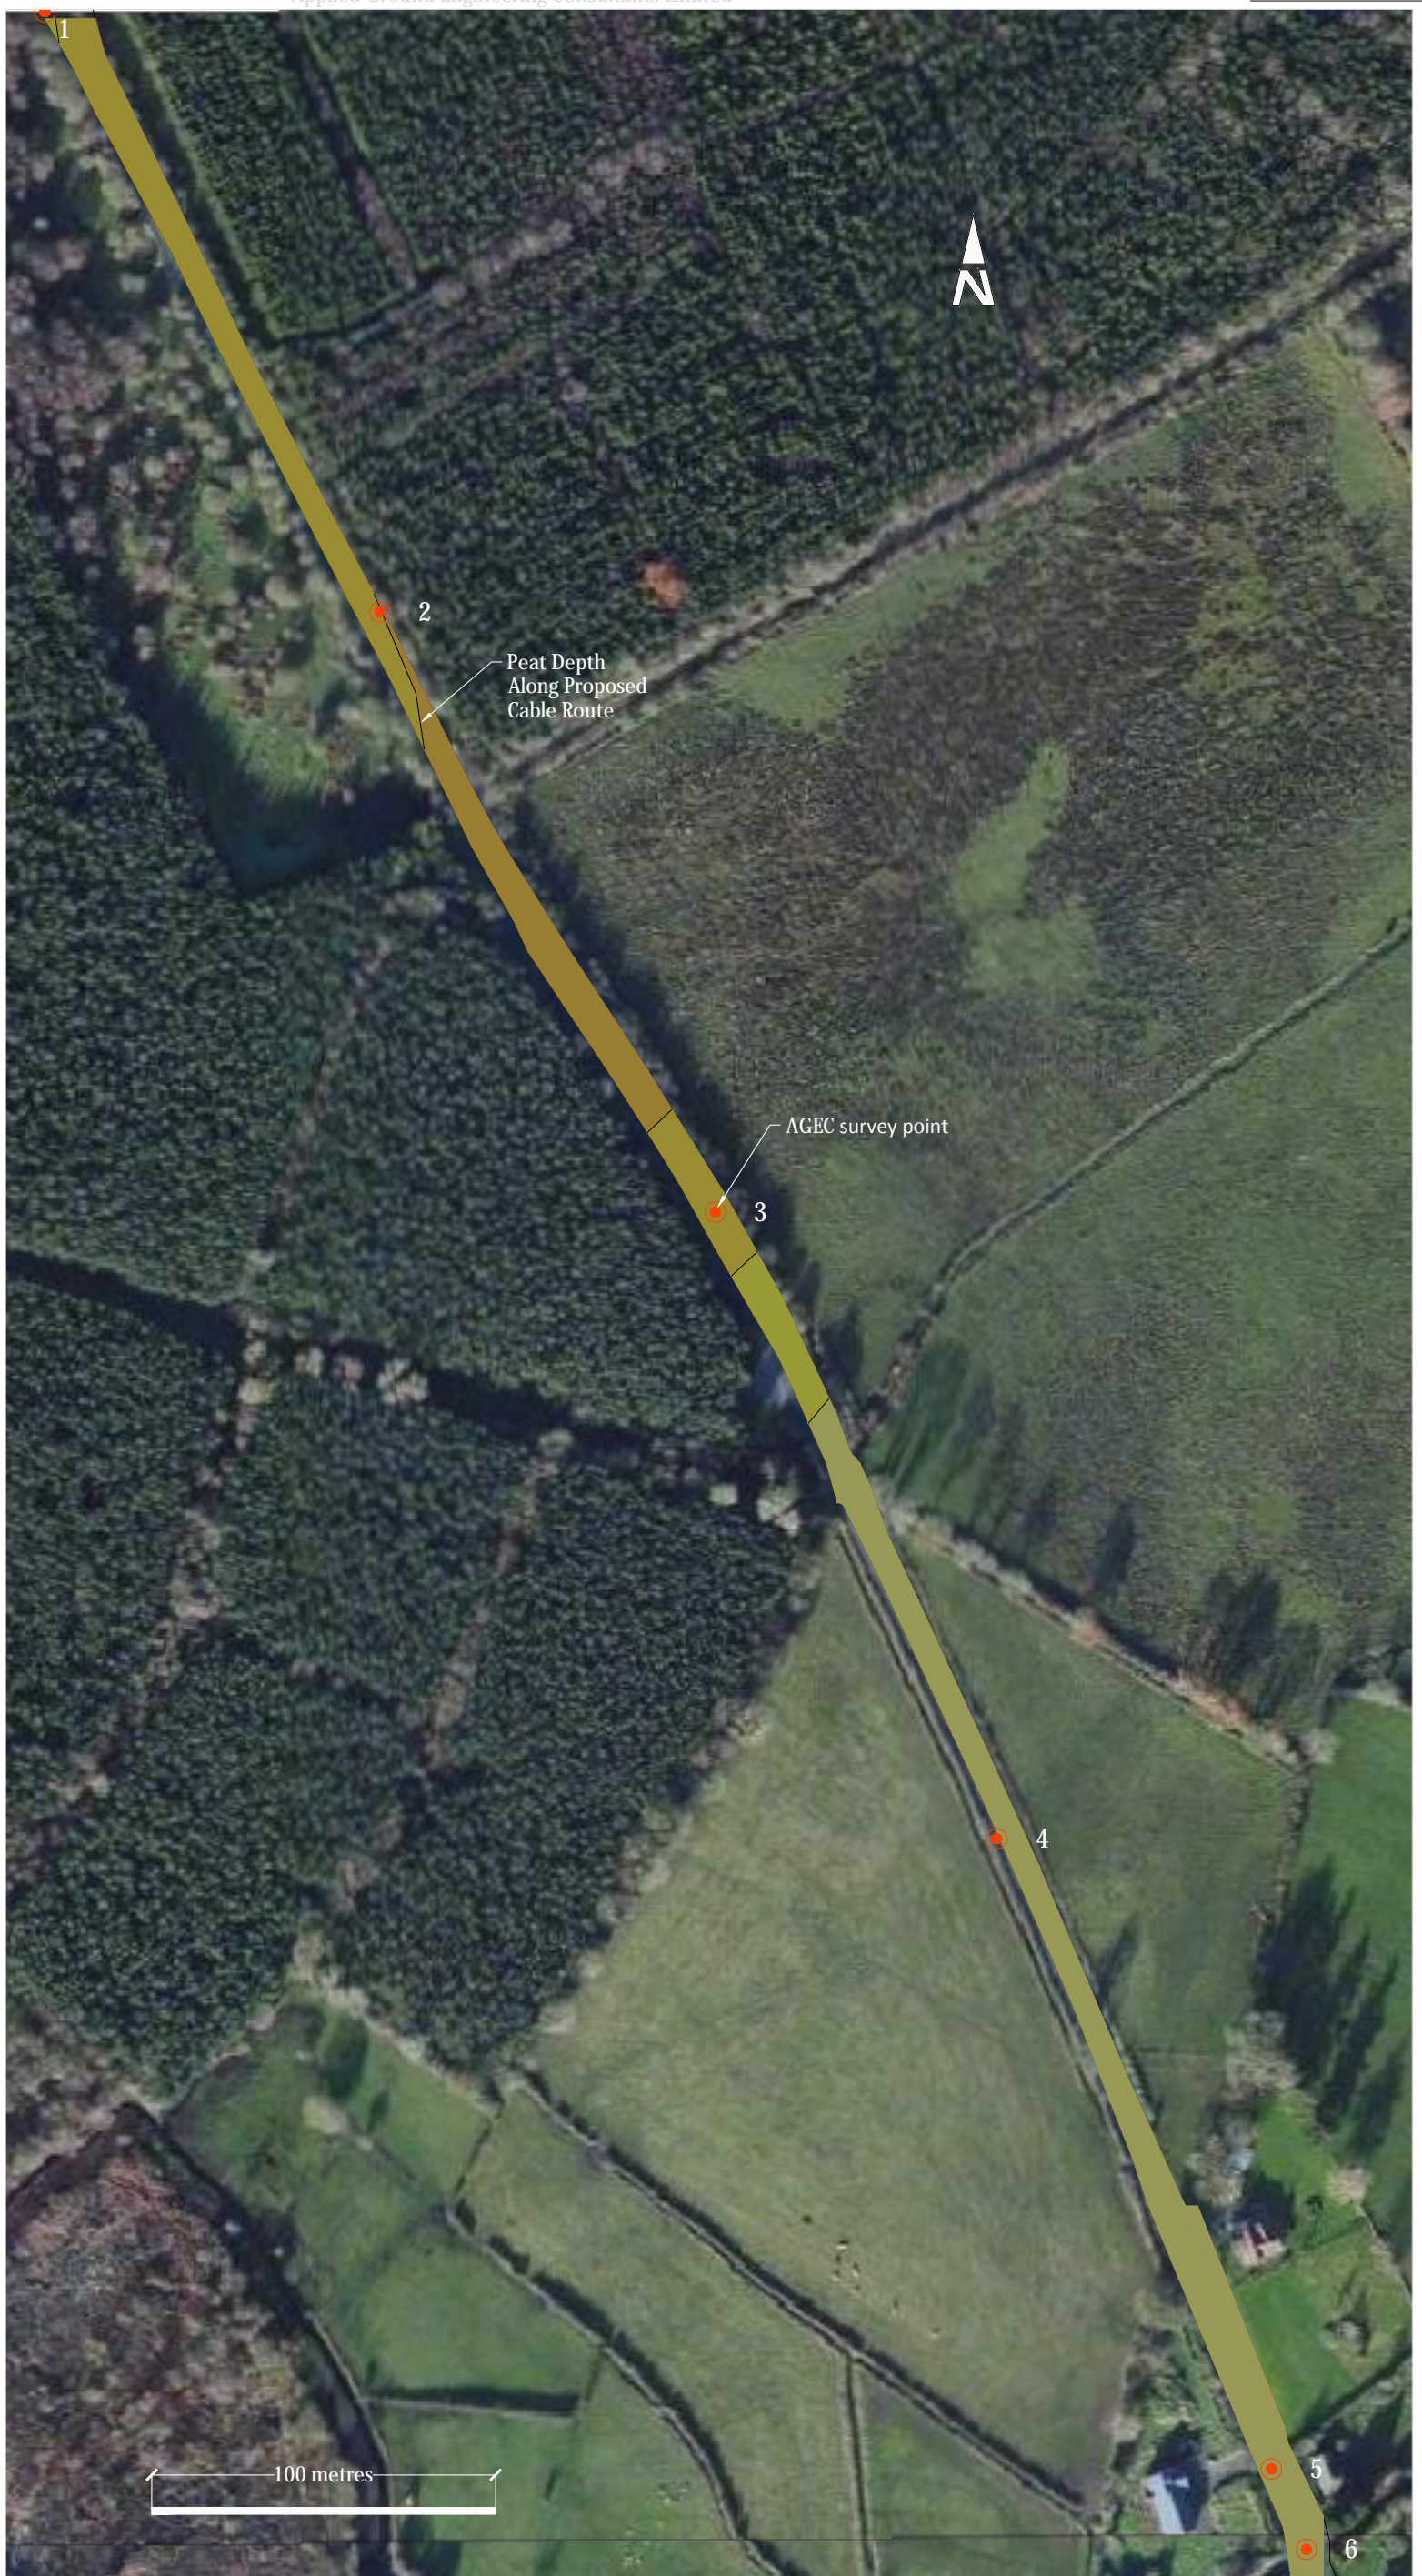
**Figure 1 - Peat Depth Contour Plan - Priority Area 1**

Peat probing was carried out along both sides of the road within the verge to determine peat depths. The results of the peat depth survey are shown on peat depth contour plans (Figures 1 to 3).

Peat depths range from no penetration up to about 6.3 m with an average depth of about 1.8 m, which excludes no penetration reading.

- About 75 % of the priority areas (see Figures 1 to 3) measured typical peat depths of less than 1.25 m.
- A typical cable trench detail is shown on Figure 5 which could be considered suitable for this condition. The trench could be located beside (road verge) or within the road.
- Trench support will be required during construction to maintain the integrity of the trench / road.

- About 20 % of the priority areas (see Figures 1 to 3) measured typical peat depths of between 1.25 m and 4.25 m.
- A typical cable trench detail is shown on Figure 6 which could be considered suitable for this condition. The trench could be located beside (road verge) or within the road.
- This typical trench section will require an excavate and replace technique of up to 3 m below the base of the trench.
- Trench support will be required during construction to maintain the integrity of the trench / road.

- About 5 % of the priority areas (see Figures 1 to 3) measured typical peat depths greater than 4.25 m with the maximum recorded peat depth of about 6.3 m.
- Various options to lay the cable in this area may include:
  - Light weight backfill to provide neutral buoyancy (floating trench);
  - Deep dig to competent stratum;
  - Mini-piles;
  - Peat stabilisation (e.g. Allu soil mixer); and
  - Vary trench route to avoid deeper peat (i.e. peat depth can vary across the road width).

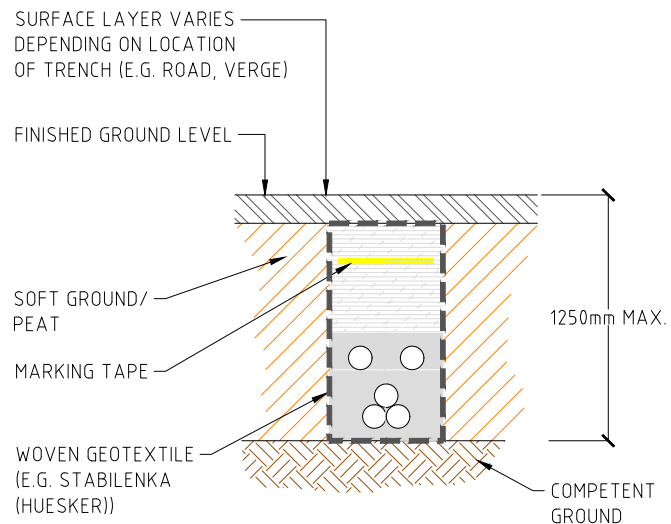
SOFT GROUND (<1250mm)

- PAVEMENT MATERIALS AND TRENCH REINSTATEMENT MATERIALS AS PER CABLE DESIGNERS REQUIREMENTS.
- TRENCH SUPPORT WILL BE REQUIRED DURING CONSTRUCTION TO MAINTAIN INTEGRITY OF THE TRENCH/ROAD.

Figure 5 - Typical Trench Section for Peat / Soft Ground (<1250mm)

- (2) Based on the information obtained during the site walkover, most of the priority sections of the proposed cable route can be constructed using typical trench details as shown in Figure 5 and 6.

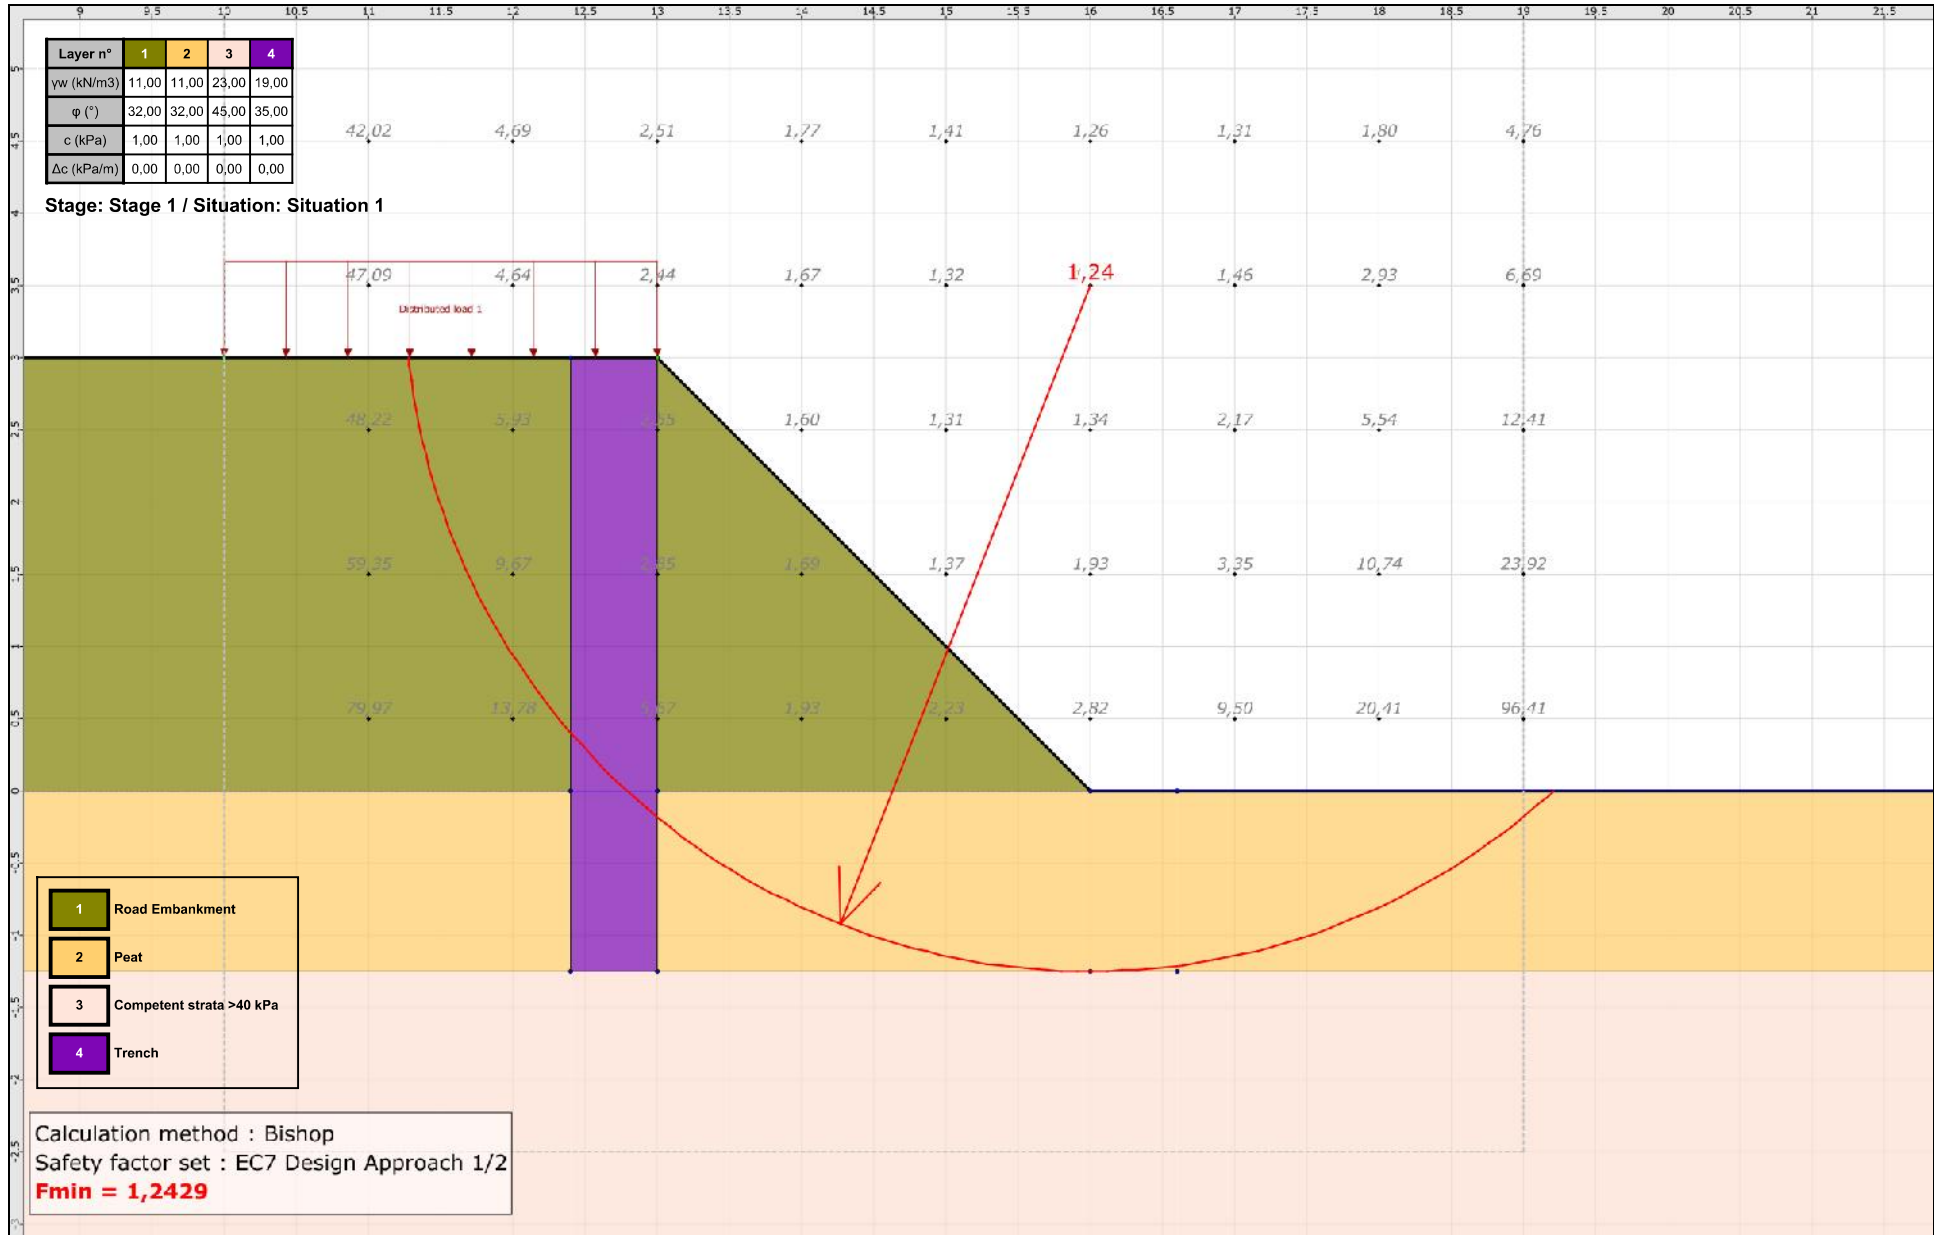
An indicative stability analysis in accordance with Eurocode 7 (Design Approach 1, Condition 2) was carried out on a typical section of the road embankment with a trench located at the edge of the road embankment (for example) and construction plant located on the road (see Figure 7). The analysis examined the drained condition using typical soil parameters.

A calculated minimum factor of safety of 1.24 was achieved. The required minimum factor of safety is 1. The results indicate that the stability of the road will not be an issue with the trench in place. For detailed design, a number of different scenarios will be examined including stability during trench construction, various trench locations (beside (road verge) / in road) and also at different road sections.

- (5) A stability analysis shows that the inclusion of the cable trench would not reduce the stability of the road embankment. For detailed design, further stability analysis will be carried out to verify the stability of the road embankment for a number of cable trench scenarios in order to choose the most appropriate construction solution.
