**GEOTECHNICAL AND PEAT  
STABILITY REPORT**

COOLE WIND FARM

**Date:** February 2021

## GEOTECHNICAL & PEAT STABILITY ASSESSMENT REPORT COOLE WIND FARM

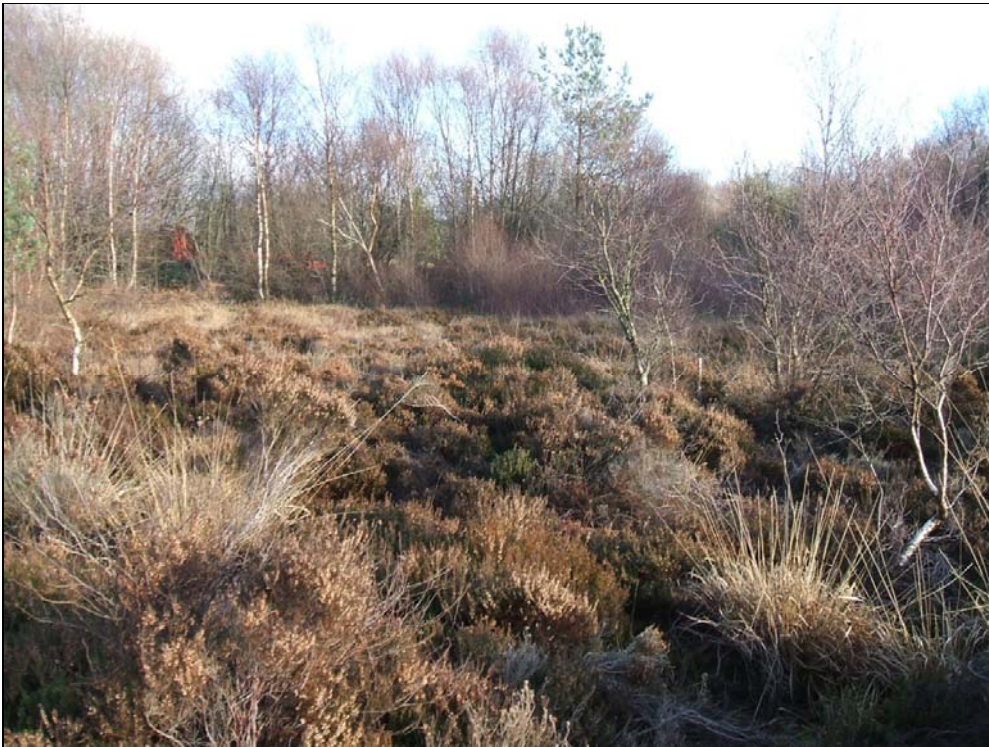
Photo 4 Example of vegetated area within construction compound footprint

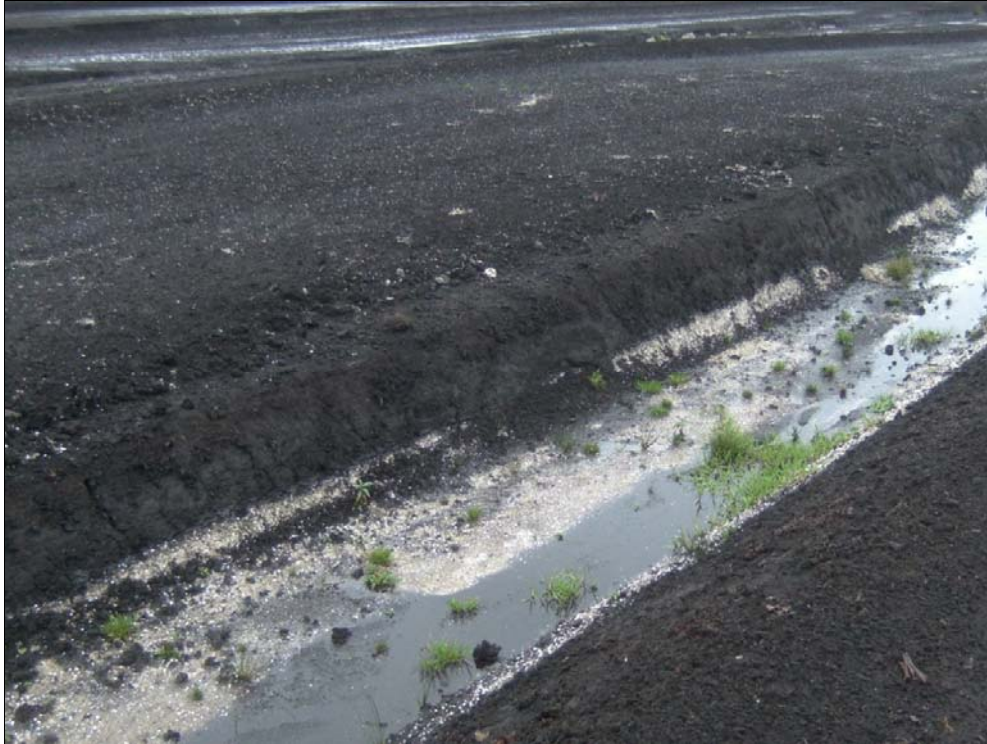
Photo 5 Example of ground conditions on site (peat overlying lacustrine deposits)

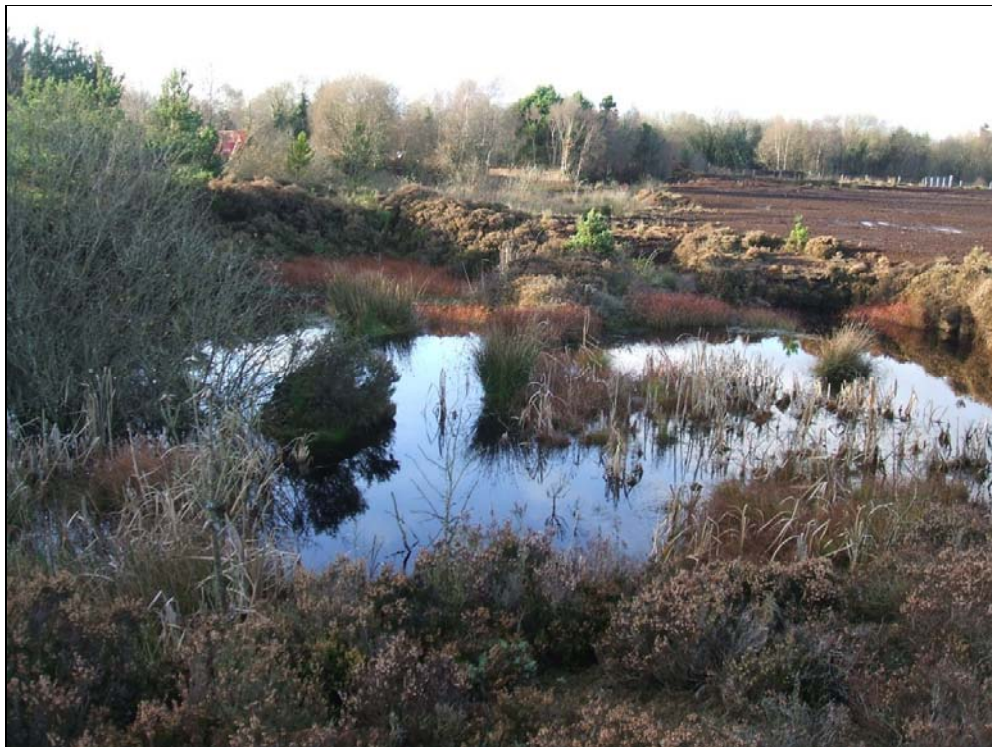
Photo 6 Existing bog pool to the south of turbine T12

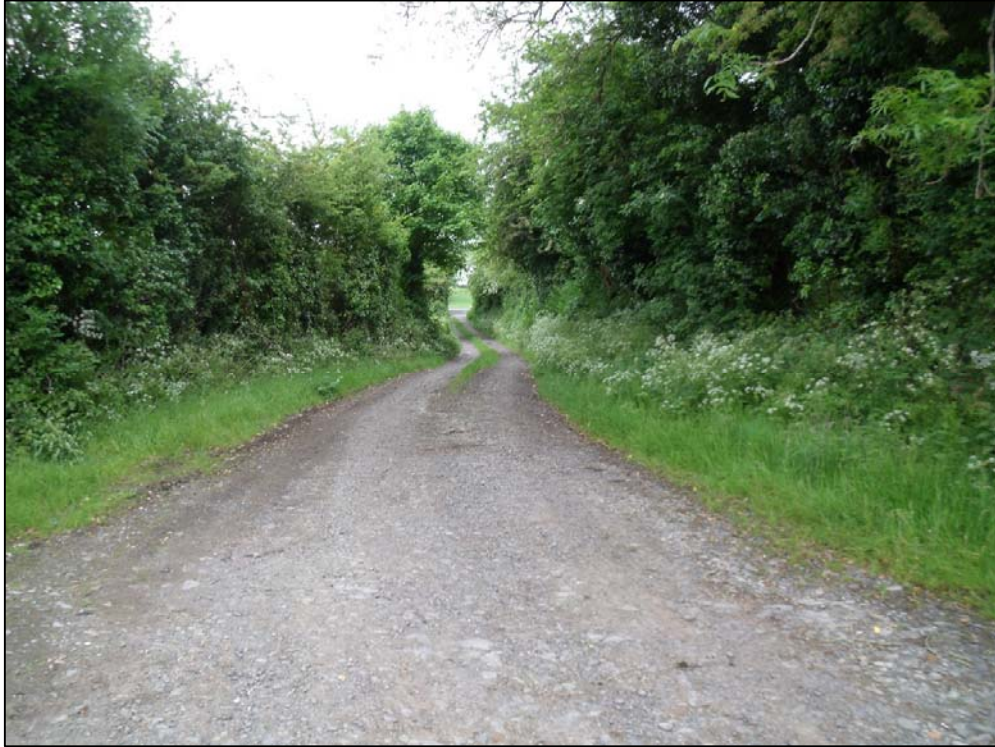
Photo 7 Section of wind turbine delivery route (existing track)

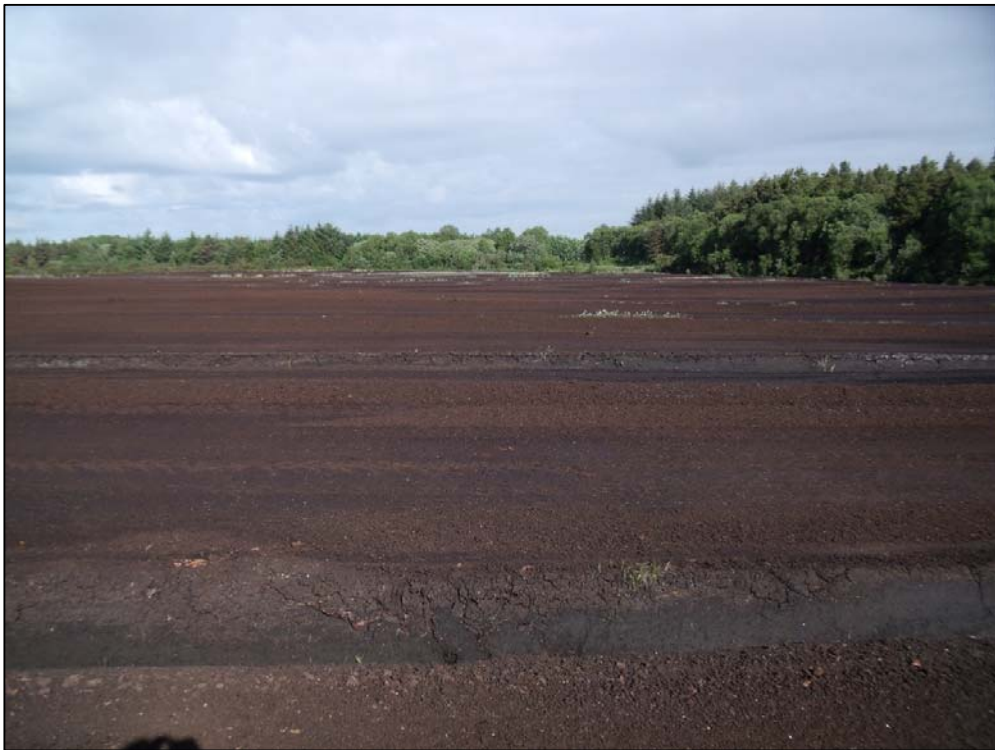
Photo 8 Section of wind turbine delivery route (through peatland)

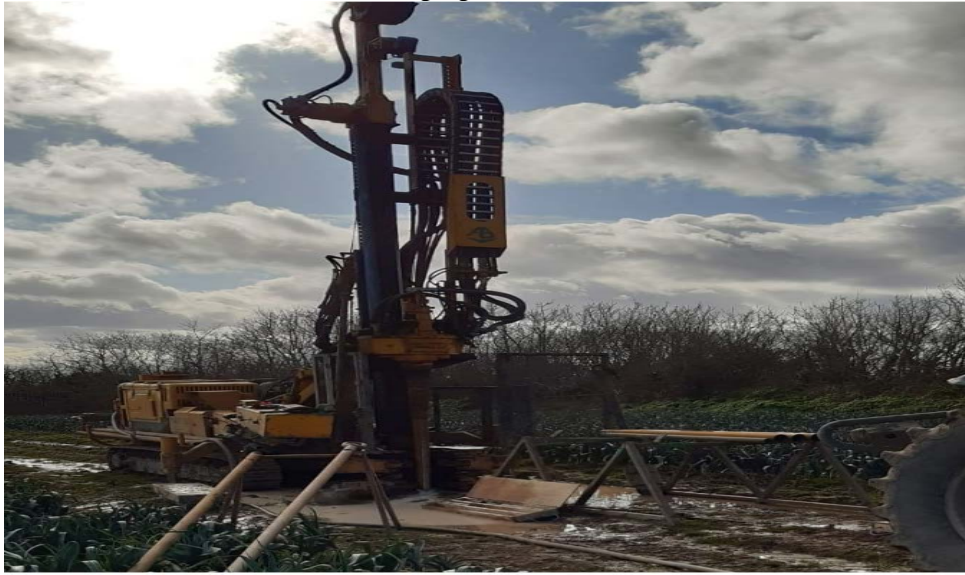
Drilling rig for Boreholes

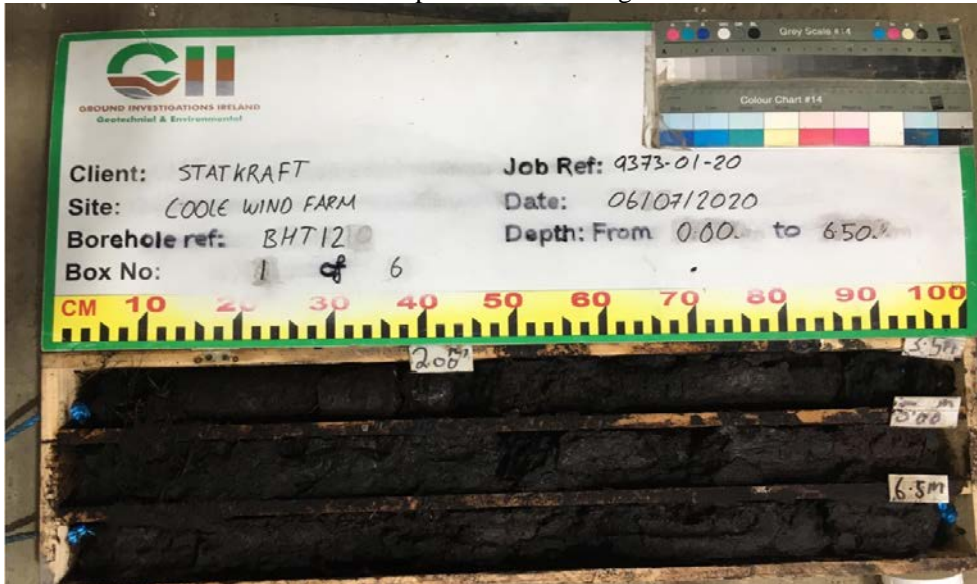
Example of Borehole logs
